**ARCHAEOLOGICAL TESTING  
ASSOCIATED WITH THE DEMOLITION  
OF THE  
FRONT PORCH AT THE FRANCIS LAND  
HOUSE (44VB0094), VIRGINIA BEACH,  
VIRGINIA**

April 2012

## MANAGEMENT SUMMARY

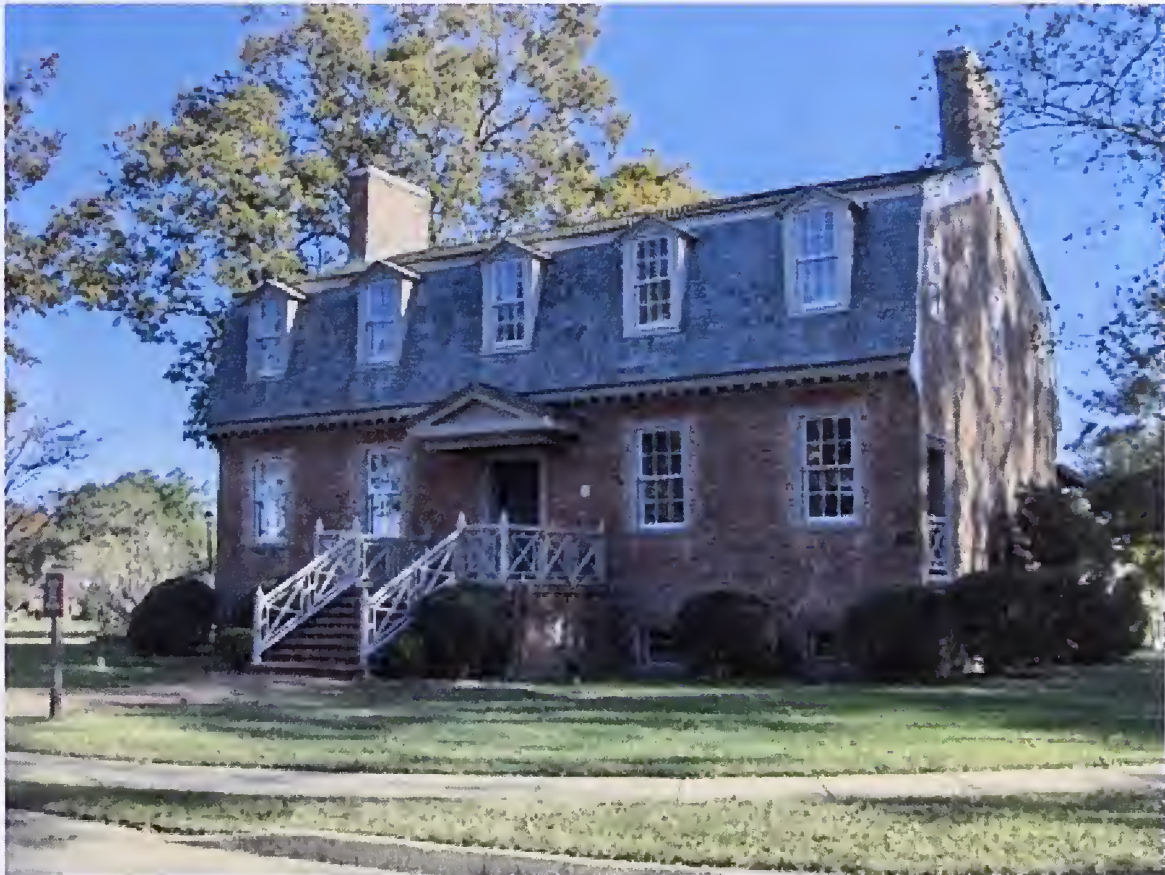
Figure 1. Francis Land House with extant 20th-century porch, southeast view.

The Francis Land House is located at 3131 Virginia Beach Boulevard in the City of Virginia Beach (Figure 1). The one-and-one-half story, gambrel-roofed brick dwelling originally was thought to have been constructed in 1732 by Capt. Francis Land III on a 689-acre plantation (Kellum and Kellum 1931:96). Subsequent architectural analysis and historical research indicates that the Francis Land House was constructed c. 1805-1810 by Francis Moseley Land (VBHPP 2008:24). The house was acquired by the City of Virginia Beach in 1975 and was listed in the National Register of Historic Places that year (VDHR 1975).

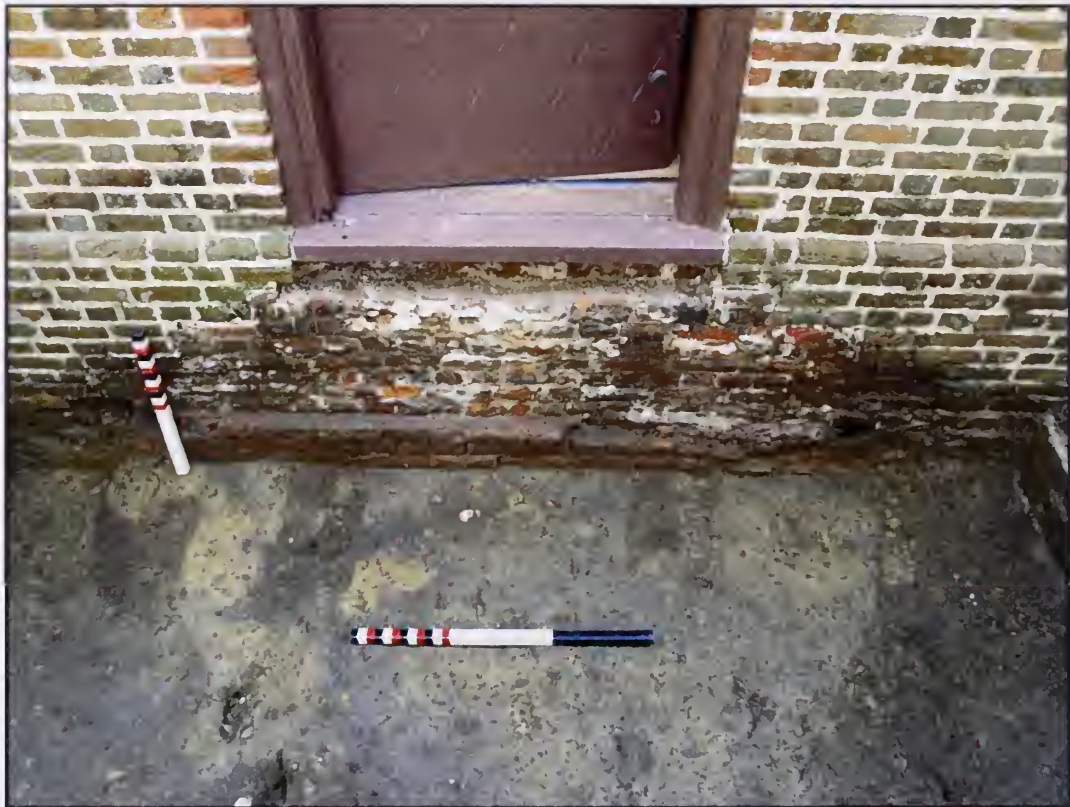
Figure 2. Eighteenth-century, porch postholes (indicated by the dark, rectangular stains) discovered at the Adam Thoroughgood House.

any evidence of surviving archaeological features associated with the original porch. A similar investigation was undertaken by JRIA of the front and back porches of the Adam Thoroughgood House which did locate archaeological features related to original framing for steps into the dwelling (Figure 2) (Higgins and Luecketti 2010). Archaeological excavations conducted by Nicholas Luecketti in front of the porch tower at Bacon's Castle also uncovered original 17th-century porch features (Luecketti 1984). Thus, it was thought that such remains might also be present at the Francis Land House.

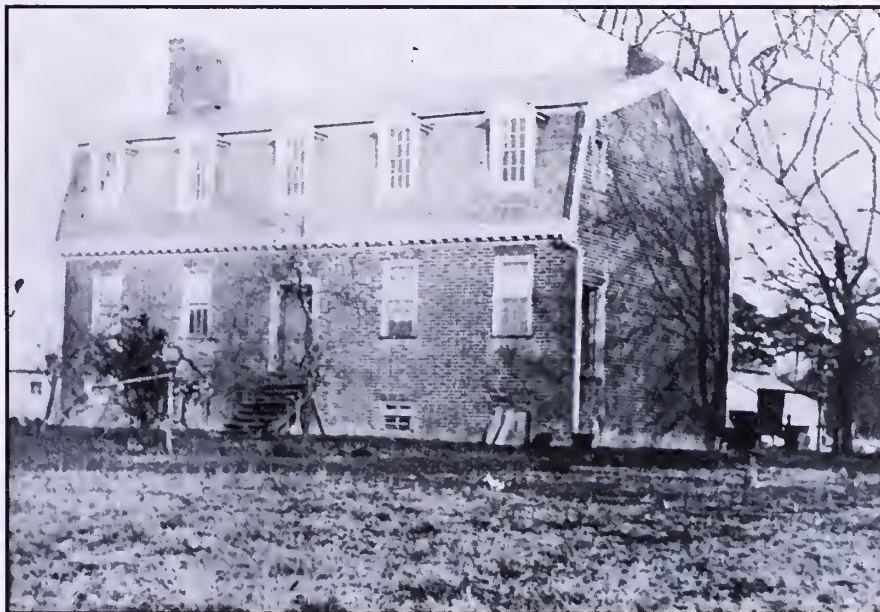
Figure 4. Francis Land House (1917), view of northwest facade (note the precarious state of the front steps).

Also found in Layer A, against the house foundation, was an apparent mold for a long since decayed board (44VB0094/4). Although the board's purpose is unknown, it appears to have been jammed into the soil to help shore up one of the early twentieth-century porches; perhaps in conjunction with a nearby, small post (see description of 44VB0094/5 below). These features may actually be depicted in an early twentieth-century photograph of the house (Figure 4).

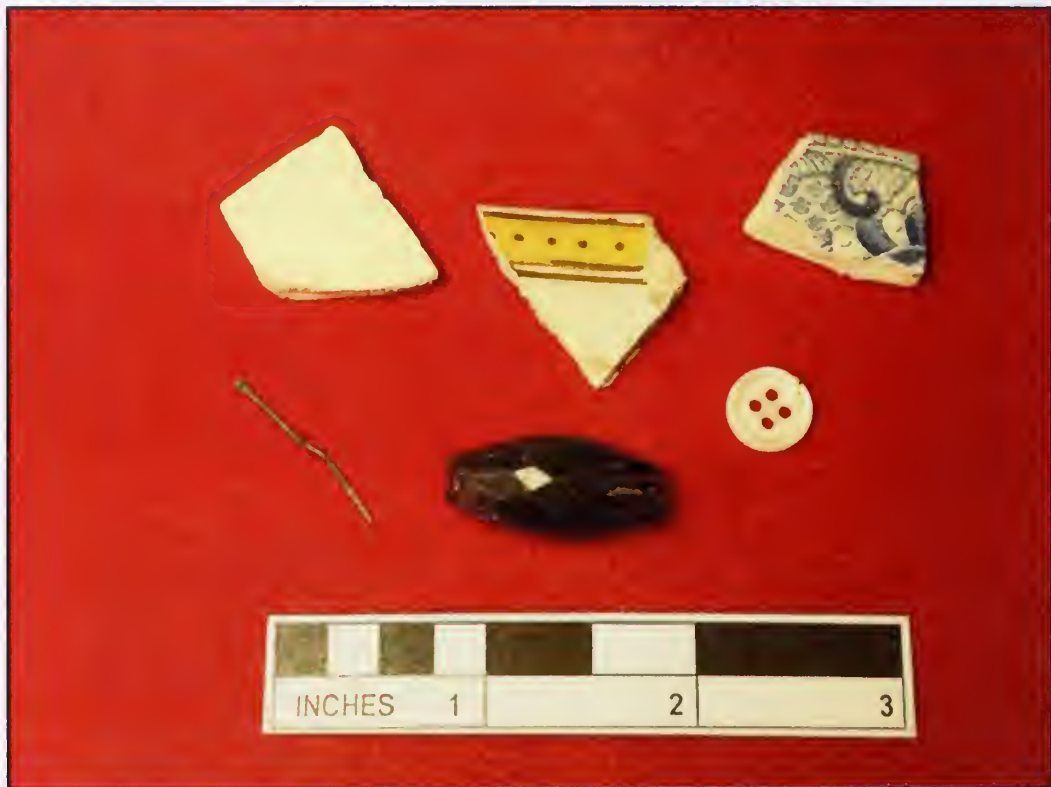
Figure 5. Selected artifacts recovered from 44VB0094.

Beneath Layer B was a brown (10YR4/3) silty clay loam (44VB0094/1C) that measured approximately 0.60 ft. thick. This deposit appeared to be remnants of an eighteenth/ nineteenth-century century topsoil. Although a few intrusive 20th-century artifacts (i.e., amber bottle glass) were encountered, a variety of earlier items such as fragments of creamware, pearlware, whiteware; nails (cut, unidentified), a copper alloy straight pin, and a dark blue, faceted glass bead were recovered from this layer (Figure 5).

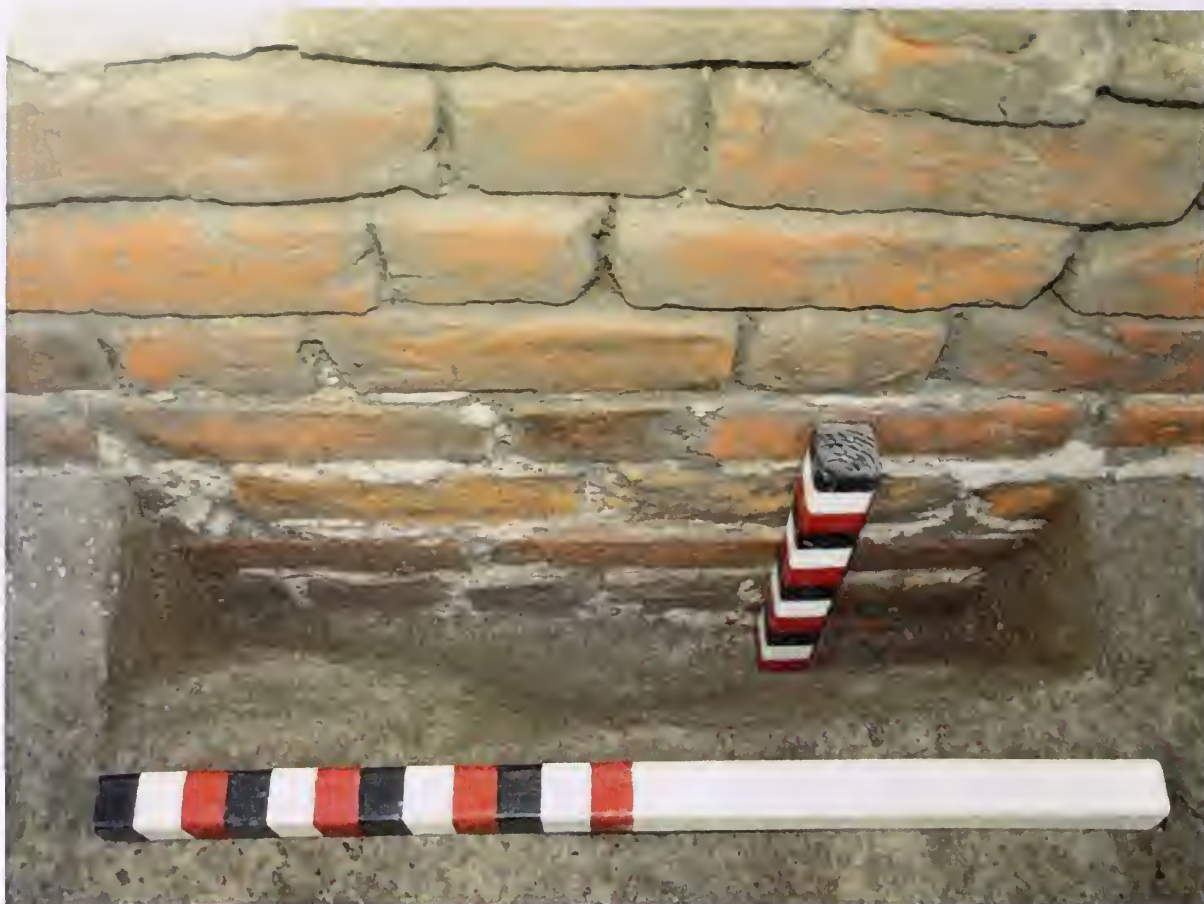
Figure 7. Excavated section of builder's trench in TU 44VB0094/1, south view.

Adjacent to the posthole on the south archaeologists found traces of the house builder's trench (44VB0094/6); from which a 2.0 ft.-section was excavated (Figure 7). This feature measured approximately 0.50 ft. wide and 0.70 ft. deep. Its fill consisted of grayish brown (10YR5/2) silty clay mottled with reddish brown (5YR4/2) silty clay. The surface of the feature was characterized by crushed oyster shell along its eastern extent. Little in the way of artifacts was recovered from the trench fill, except for pieces of shell, bits of hand-made brick, and fragments of oil lamp globe glass. This glass could potentially date to the late eighteenth century, though more pervasive on nineteenth century sites.

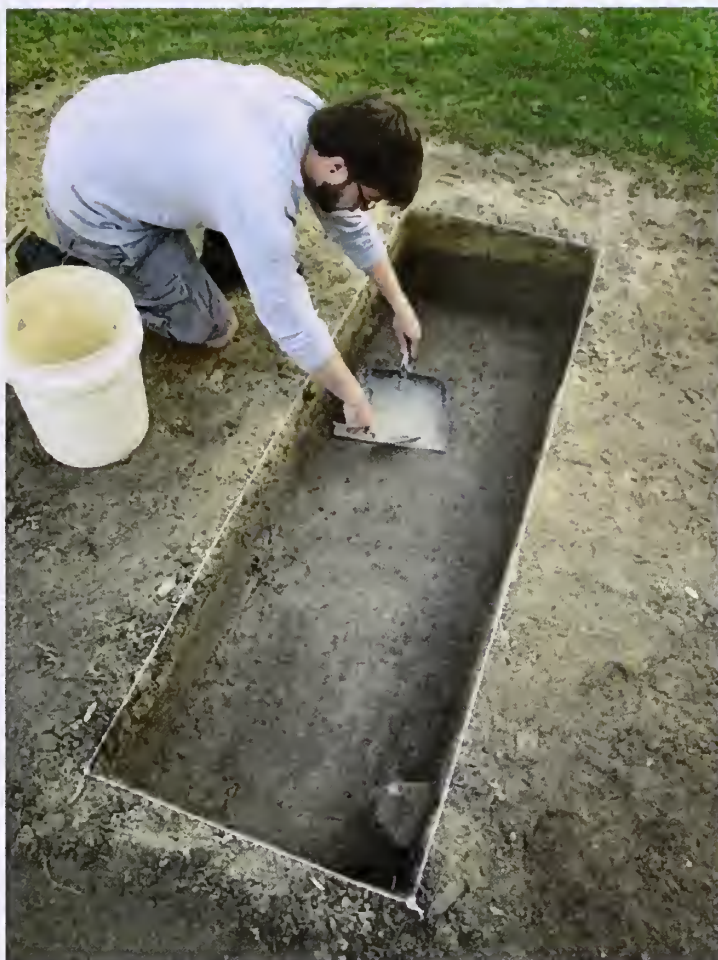
Figure 8. Excavation of TU 44VB0094/3 [TU2] at former location of modern walkway, north view.

Test Unit 2 (44VB0094/3) was a 7.50 x 2 ft. test unit located on the north side of the twentieth-century porch foundations and steps, and crossed remnants of a modern, brick walkway aligned with the entrance to the house (see Figure 3; Figure 8). As previously described, the purpose of Test Unit 2 was to determine if evidence of a historic walk survived beneath the later construction. Although excavation results proved to be negative in this regard (as evidenced by the absence of historic features) a significant deposit was encountered beneath the modern walkway sand fill (44VB0094/3A). Layer 44VB0094/3B was a dark grayish brown (10YR4/2) sandy clayey loam that ranged from about 0.50 ft. up to 0.70 ft. deep and, as with Layer C in Test Unit 1, might well represent remnants of an historic topsoil. It contained fragments of brick, roof slate, oil lamp globe glass, unidentified nails, animal teeth, and ceramics, among other items. The ceramic collection includes eighteenth- and nineteenth-century types such as creamware, pearlware, whiteware, and stoneware; these probably represent plate, bowl, and storage jar forms.

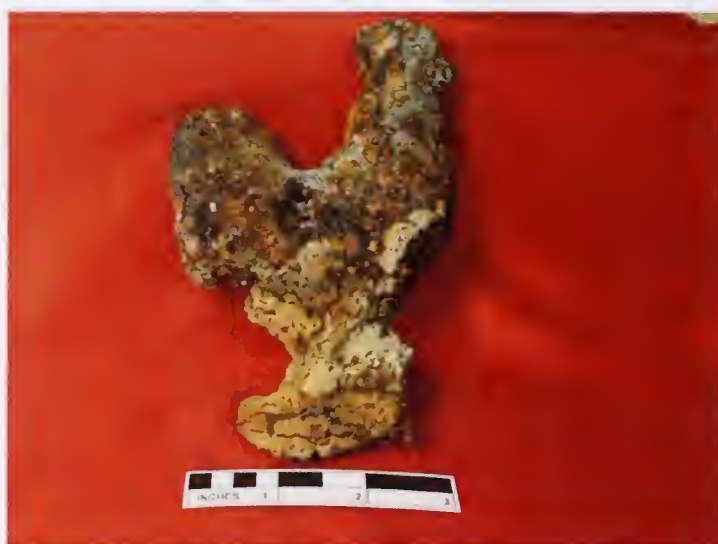
Figure 9. Ornamental rooster found in TU44VB0094/8C.

Test Unit 3 (44VB0094/8) was a 2 ft<sup>2</sup> test unit located adjacent to the house 2.70 ft. east of Test Unit 1. Like Test Unit 1, its purpose was to determine if any trace of an eighteenth-or nineteenth-century porch structure survived beneath the doorway. Layers A-C proved to be identical to those encountered in Test Unit 1. Layers A and B are most likely fill deposits associated with episodes of porch construction during the twentieth century; Layer C may represent a significant historic deposit. Layer C consisted of a uniformly brown (10YR4/3) silty clay loam that was encountered approximately 0.50 ft. below ground surface. It yielded a relatively dense concentration of late nineteenth-century artifacts; so much so that these appeared to be part of a primary refuse disposal event discretely discarded beneath front porch. Recovered items include a complete whiteware cup, bottle glass, a wine glass knob, a medicine vial fragment, a possible key hole escutcheon, a copper alloy button, a large conch shell, an Indian Head penny (1882), and an iron, ornamental rooster, among other items (Figures 9 and 10).
